**Re: Rice Drilling D, LLC
NSPS Subpart OOOOa Annual Report**

Rice Drilling D, LLC
NSPS Subpart OOOOa Annual Report

Big Dawg 1HA, 3HA, 5H, 7H Leaking Components Report

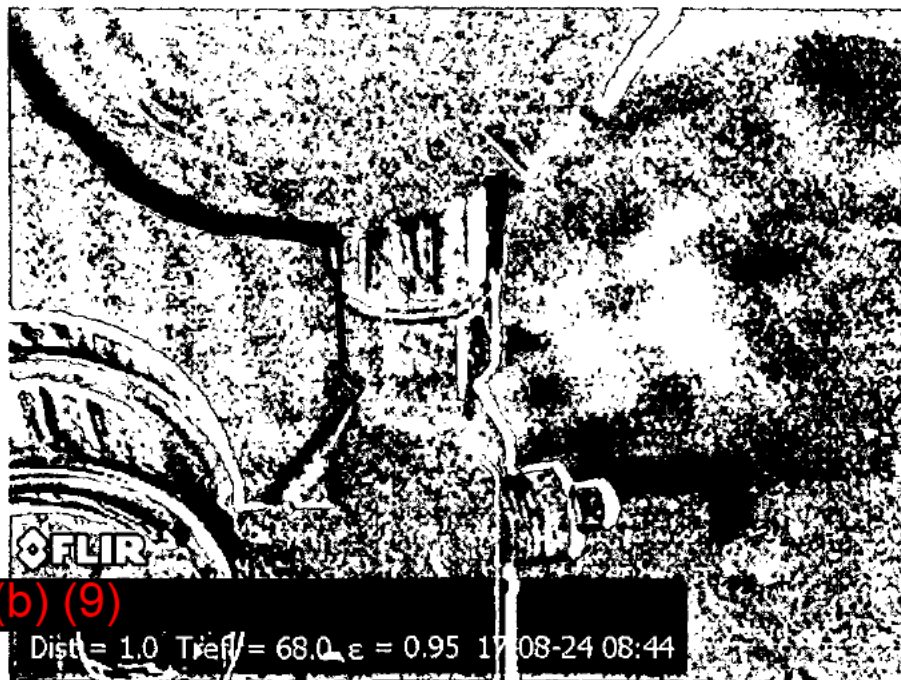
BIGD-20170824-001IR Repaired

Location: 7H Well Head Casing Transducer

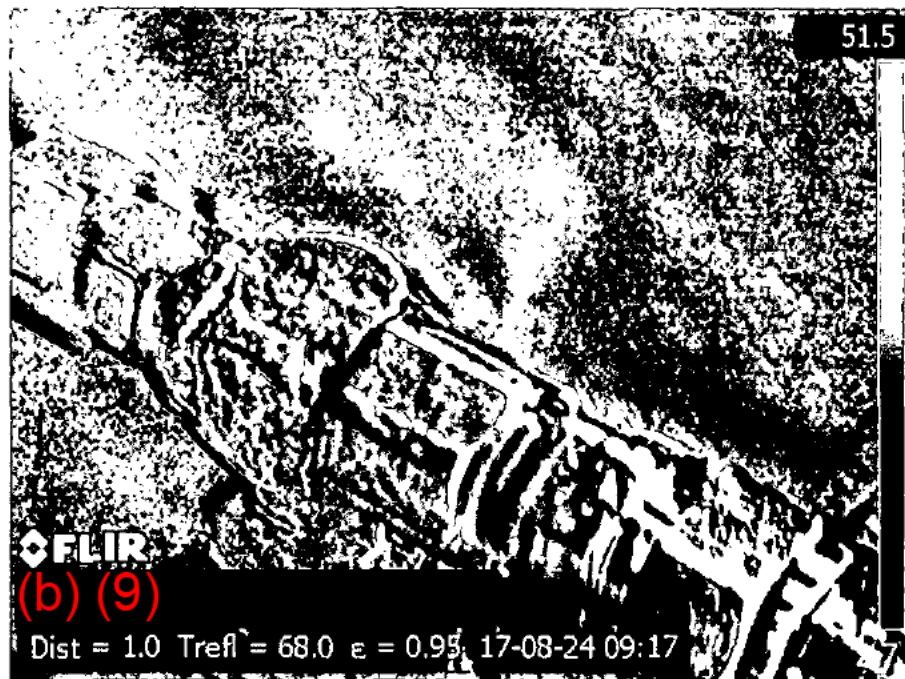
BIGD-20170824-003IR Repaired

Location: 7H GPU Run 1 High- Low Quick Exhaust

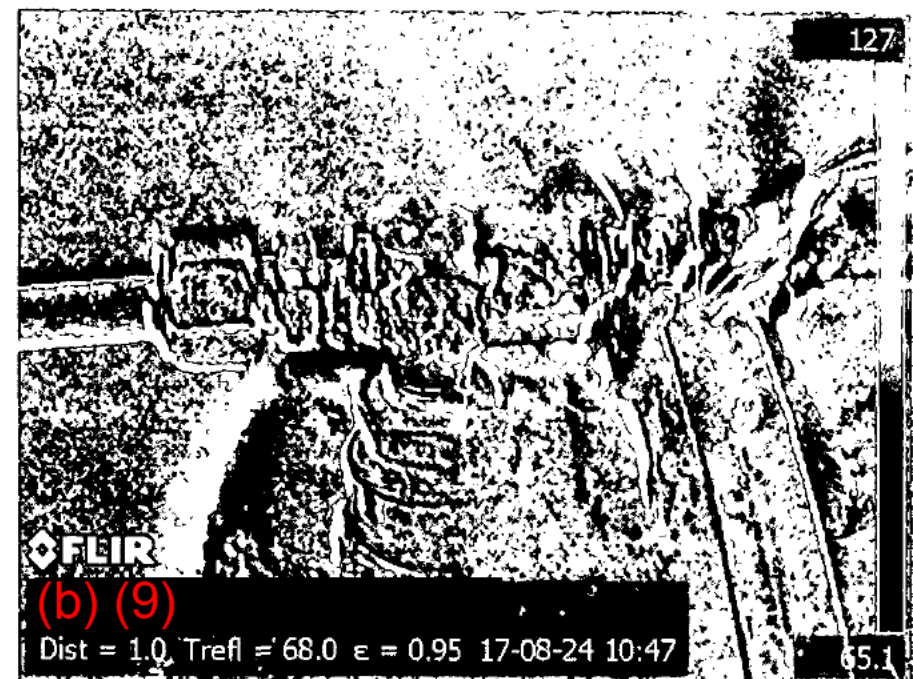
BIGD-20170824-004IR Leaking

Location: 7H GPU Run 1 Supply Line 90

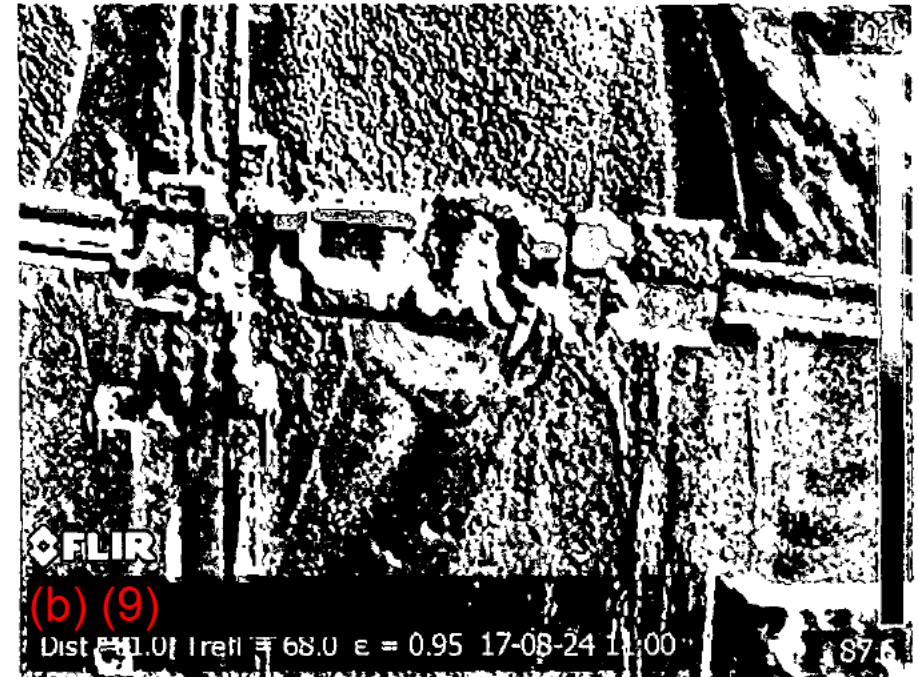
BIGD-20170824-006IR Leaking

Location: 7H GPU Run 2 ESD Diaphragm

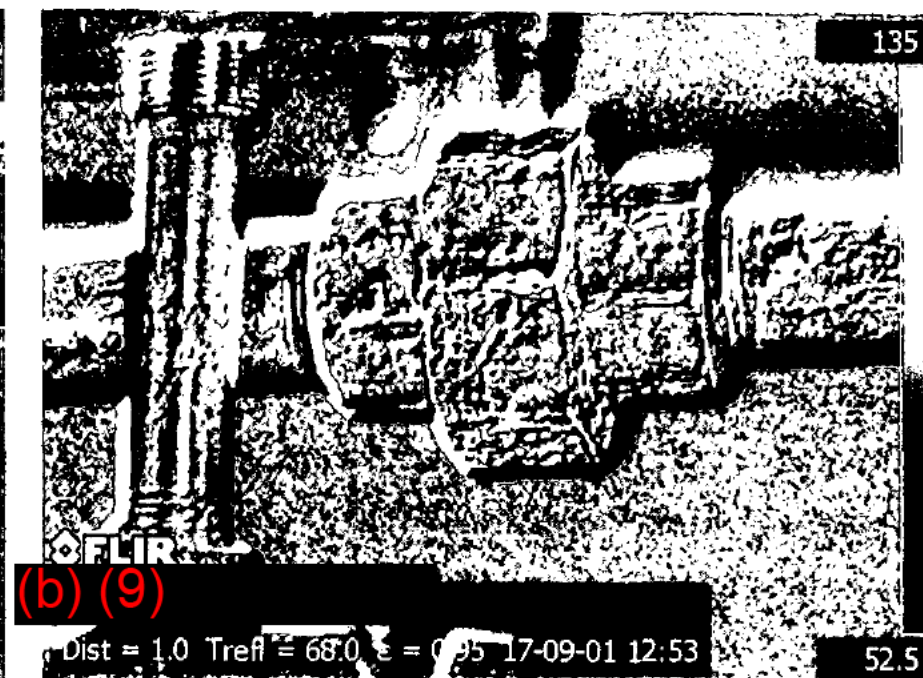
BIGD-20170824-008IR Leaking

Location: 3HA GPU Run 2 High- Low Quick Exhaust

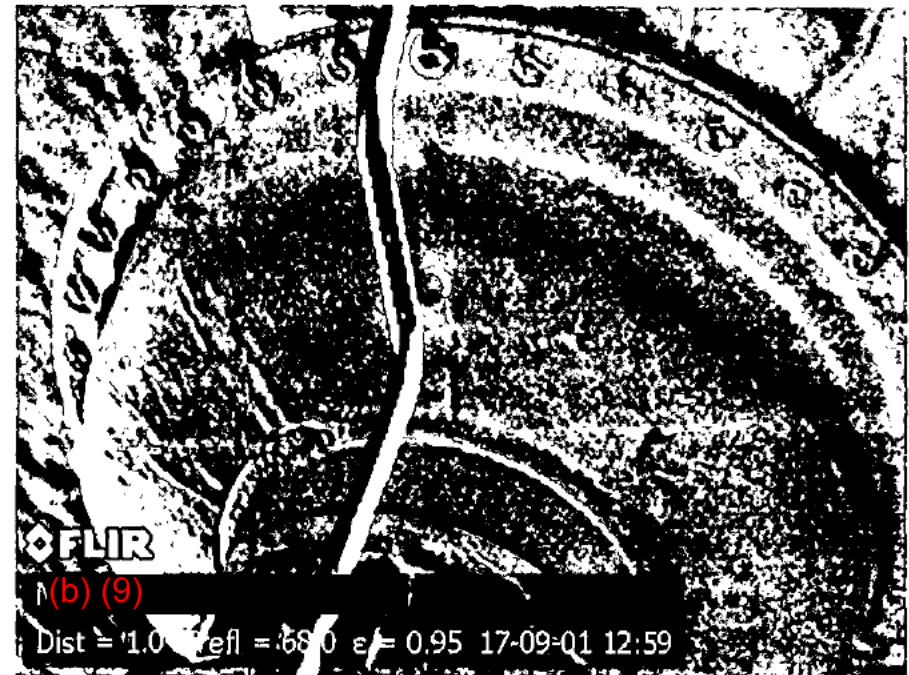
BIGD-20170824-011IR Leaking

Location: 1HA GPU Run 2 Stainless Fitting

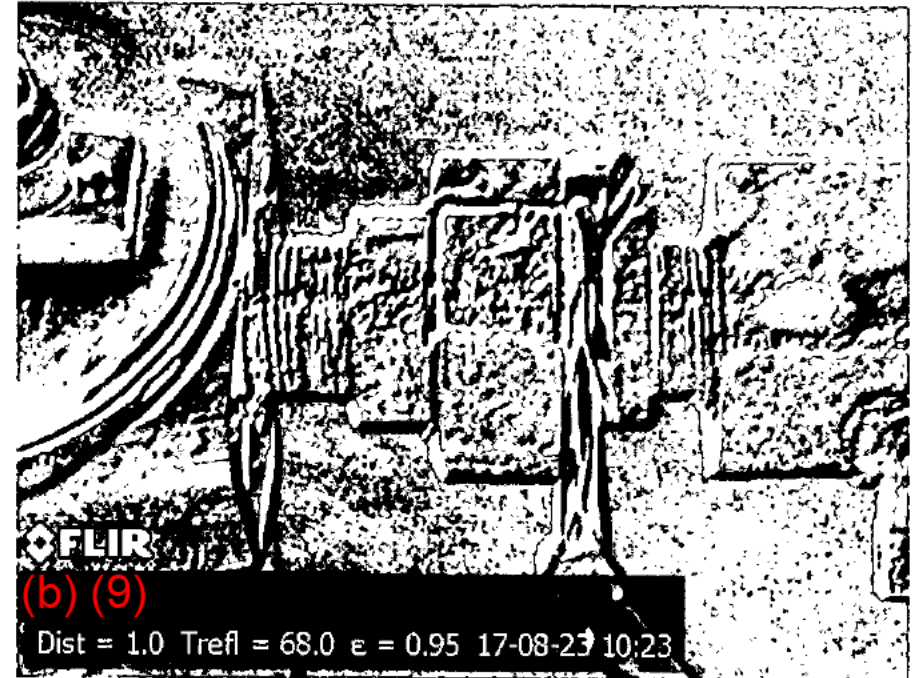
BOUN-20170823-002IR Leaking

Location: 2H GPU Run 2 Fuel Gas Union

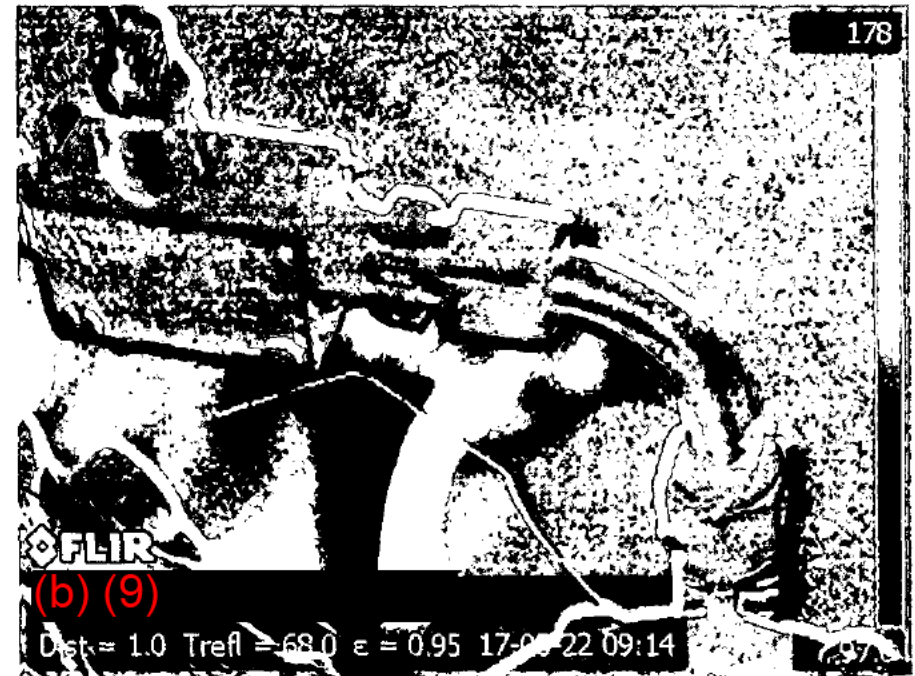
DRAW-20170822-006IR Leaking

Location: 1H GPU Run 1 Stainless Fitting

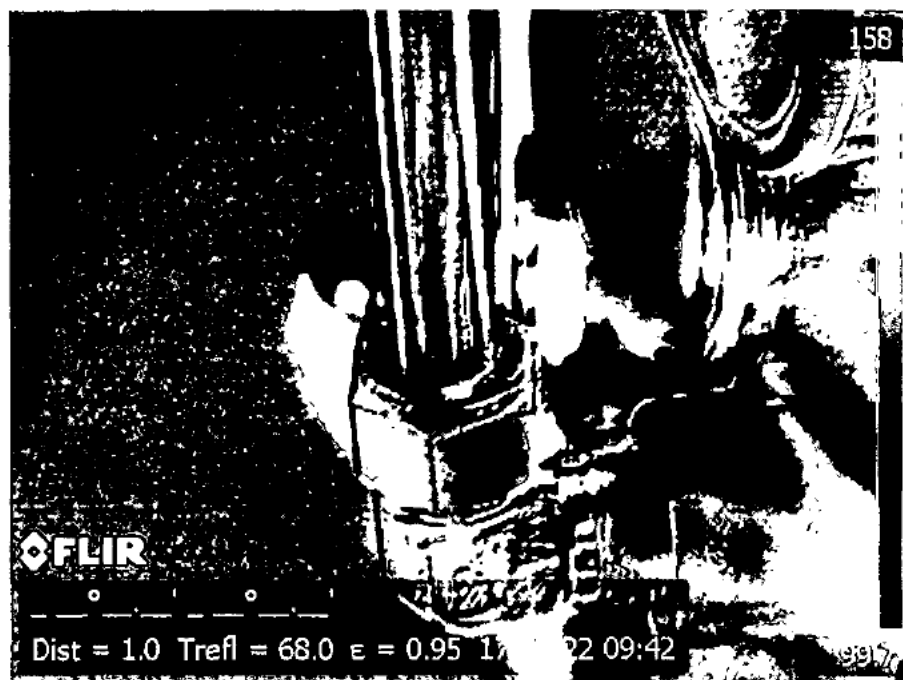
DRAW-20170822-009IR Repaired

Location: 3H GPU Run 1 Fuel Gas Stainless Fitting
